# Moisture in compact roofs - Results of a two-stage field survey

## **SUMMARY:**

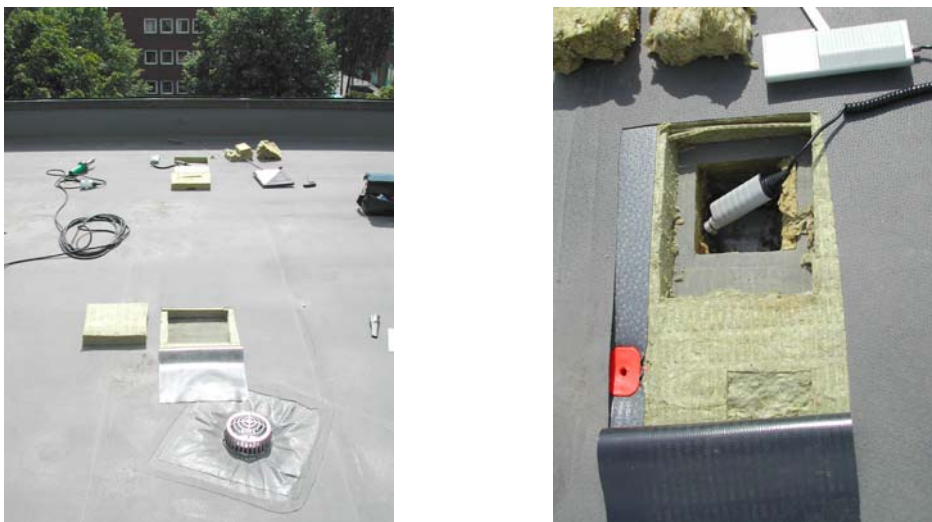
*FIG. 1: Roof No. 11. A building from 1980 that was re-roofed late autumn 2000. Pictures taken during survey in Phase 1 June 2002.*

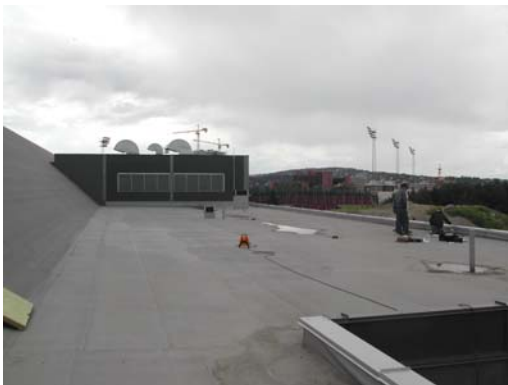
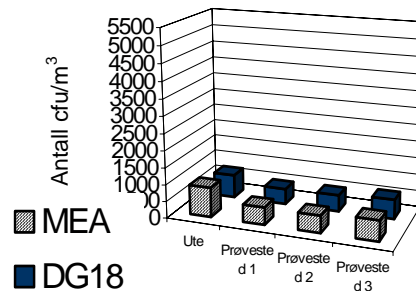
Fig. 2: Example Roof No.10. Overview as well as graphic reproduction of results from the air analyses. Number of cfu/m<sup>3</sup> is shared between sampling point and cultivation medium (MEA/DG18) (Phase 1)

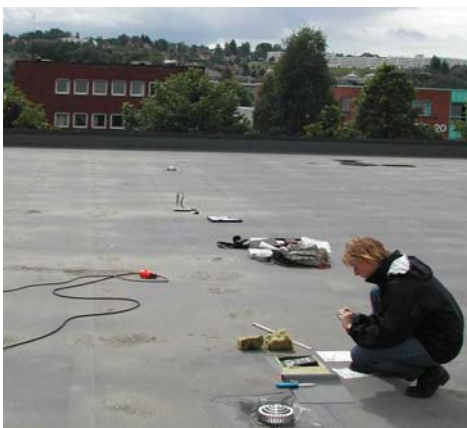
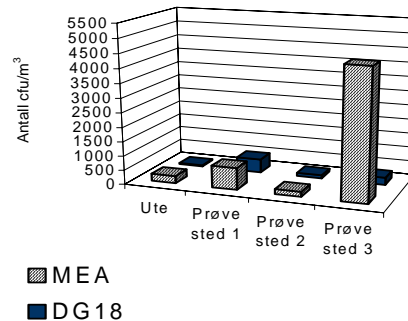
- Roof No. 11 had a high concentration of bacteria and yeasts in one of the test holes in Phase 1. The amount of fungal spores was greater in 2004 than in 2002, something that indicates growth during the period. Considering the construction had been standing wet for several years, the level of biological activity was however relatively low.
- Roof No. 12 had proven moderate to substantial growth of two kinds of moulds, and is probably already suffering from established fungal damage.

Fig. 3: Example Roof No. 11. Overview as well as graphic reproduction of results from the air analyses. Number of cfu/m<sup>3</sup> is shared between sampling point and cultivation medium (MEA/DG18) (Phase 1)

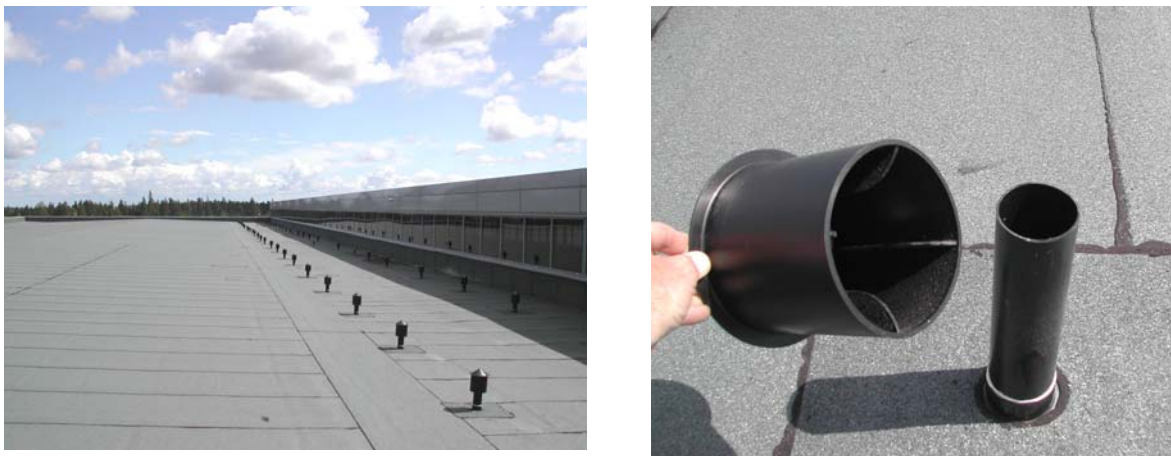
Fig 4. Overview of roof No. 6 in the investigation and details of ventilation louvre (photo: NBI)

*Use of ventilation louvres. In order to assist with the drying out of building moisture, ventilation louvres were installed on two of the roofs (Roof Nos. 4 and 6) after the building was completed but prior to the examinations in Phase 1. The sizes, quantity and locations were different on the two roofs. When we returned to implement Phase 2 we could see that the ventilation louvres had been removed from both roofs. We were told that this was because the roofs in the meantime were considered to be dry and that ventilation louvres were therefore no longer necessary. As an example we would mention roof No. 6: A large number (64) of ventilation louvres were retrofitted in the bituminous roof covering (see fig 4). The moisture content of the mineral wool in Phase 1 was measured as being 1.0 % (volume). This is a fairly high moisture content. The position of the sampling point was approx. 2 m away from four of the ventilation louvres. As we do not know how much moisture was present in the roof from the start, it is difficult to judge the effect of the ventilation louvres up to the examination in Phase 1. The drying out that was registered between Phase 1 and Phase 2 (measured value in Phase 2 was 0.06 % by volume) is however so large that dehydration mechanisms other than pure diffusion must have had a significant effect. It therefore looks as if the ventilation louvres have made a positive contribution.*
